Docket No. 217 – Development and Management Plan Inspection

Northeast Utilities Service Company Certificate of Environmental Compatibility and Public Need for the construction of a 345-kV electric transmission line and reconstruction of an existing 115-kV electric transmission line between Connecticut Light and Power Company's Plumtree Substation in Bethel, through the towns of Redding, Weston, and Wilton, and to the Norwalk Substation in Norwalk, Connecticut.

Date: August 3, 2006

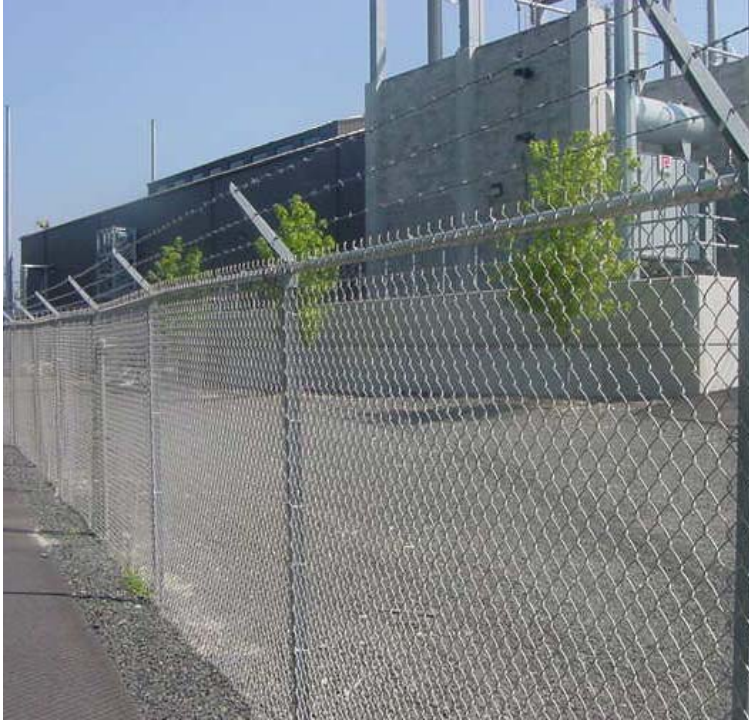
(Norwalk Substation): Photo on the left shows recently planted trees along the GIS building retaining wall. Photo on the right shows the stones in place around the turning structure base to repair the erosion. Re-vegetate the adjacent bank if feasible. 8/3/06

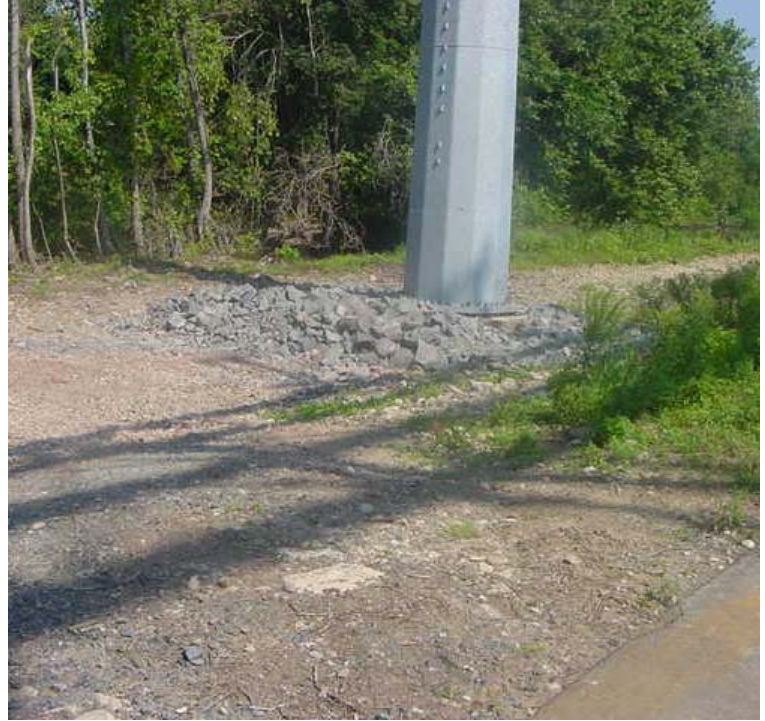
- MJ Electric remain on site to pull ropes and wire. 8/3/06	- None at this time. 8/3/06	-N/A
	-Stone remains around the base of the 345kV turning structure to repair the erosion. 8/3/06	-Continue to monitor. Consider re-vegetating the adjacent bank if feasible 8/3/06	- N/A
Erosion and Sediment Controls	- Erosion on the slope of the river appears to be forming again. 6/28-8/3/06.	- Continue to monitor and attempt to make the area more natural/ vegetated if feasible. 5/25-8/3/06.	-N/A

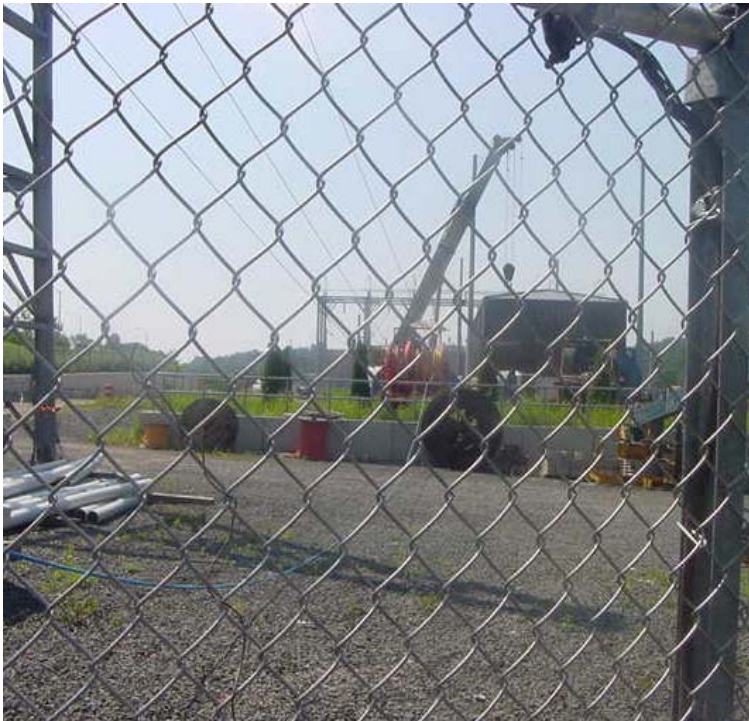
Photo on the left shows a view of the rear of the substation where wire pulling equipment is in place. (Plumtree Substation): Photo on the right shows a view of the work in progress in the yard.
